# *Certified Inspection Services of S.W. FL, LLC*

## Property Inspection Report

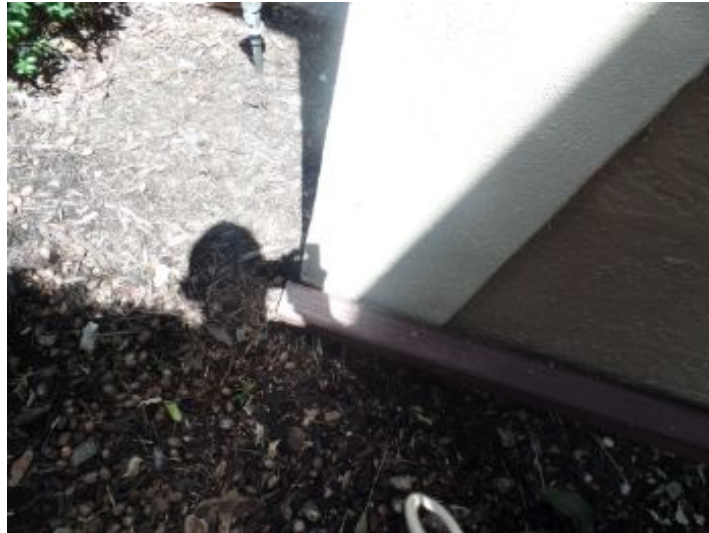
Recommend extending gutter downspouts a minimum 12" from foundation

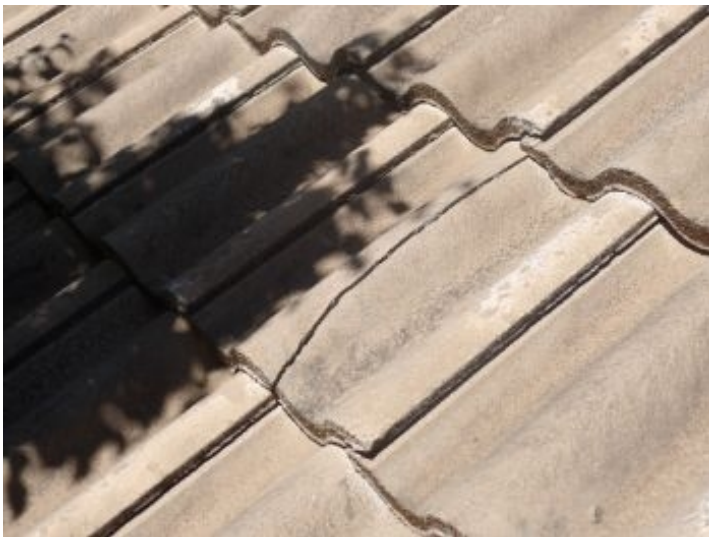
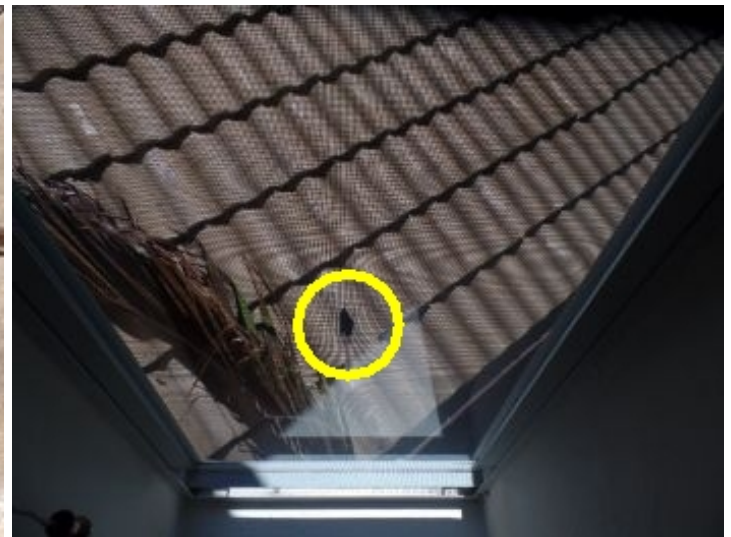
Cracks/small holes noticed in several tiles on roof. Although the main function of the tiles are to protect the actual roof underneath, nevertheless, they should be refastened/repared to help prevent blowing off in the event of a high wind situation.

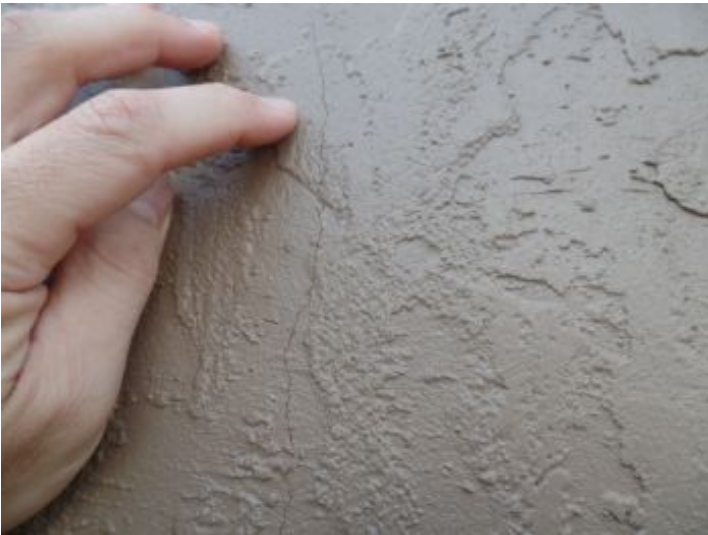
Minor cracks / holes (1/8" or less) present in exterior wall. Consider sealing them to prevent water infiltration. Generally speaking, cracks that are less than 1/8" are not commonly regarded as being structurally significant. Nonetheless, they should be monitored to see if there is active movement in this area.

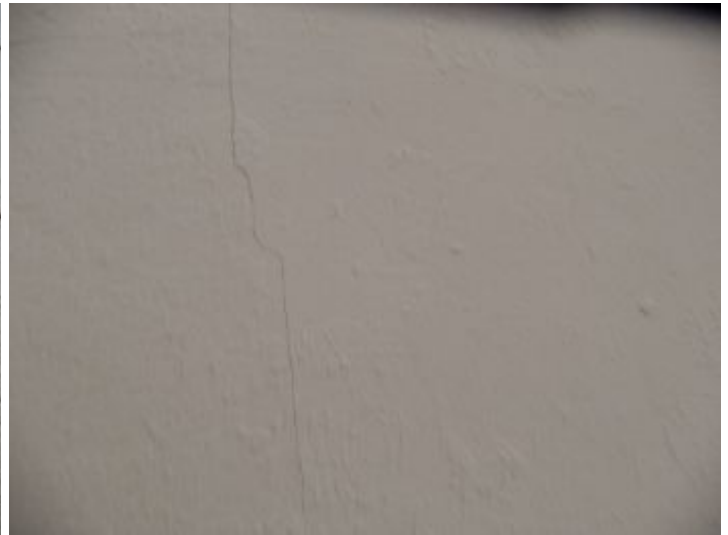
Minor cracks (1/8" or less) present in interior walls. Generally speaking, cracks that are less than 1/8" are not commonly regarded as being structurally significant. Nonetheless, they should be monitored to see if there is active movement in this area.

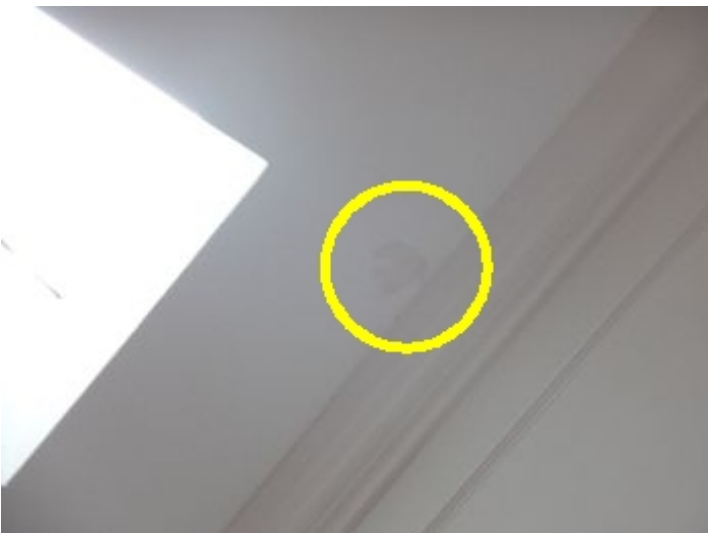
Small stain visible at living room near the sky light. Could not test due to ceiling height

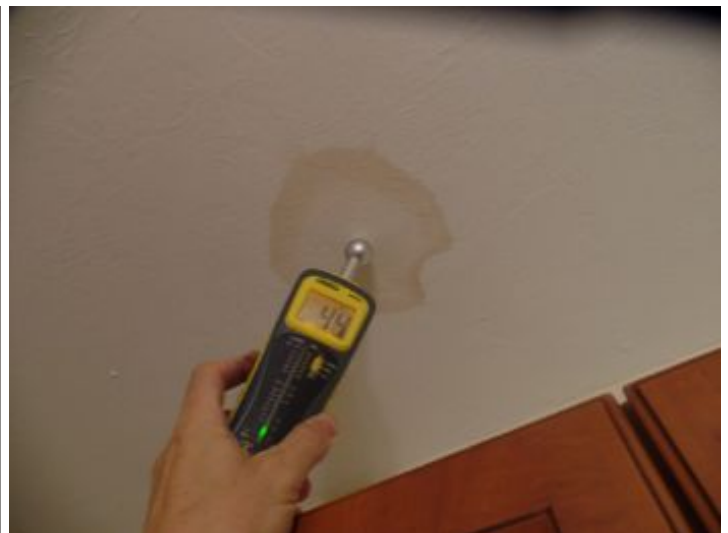
Stain visible at butler pantry ceiling, This was tested with a moisture meter and found to be non active at this time, however we recommend monitoring

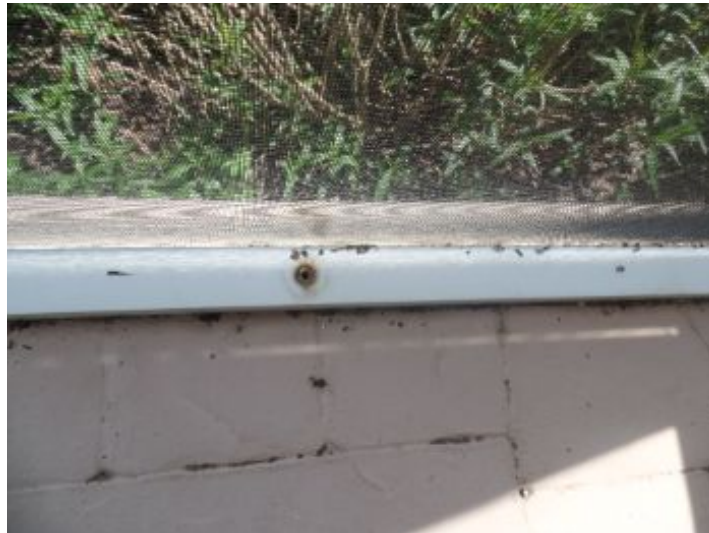
Fasteners are rusting and missing at various areas on the screen cage, mainly at the bottom track deck connection

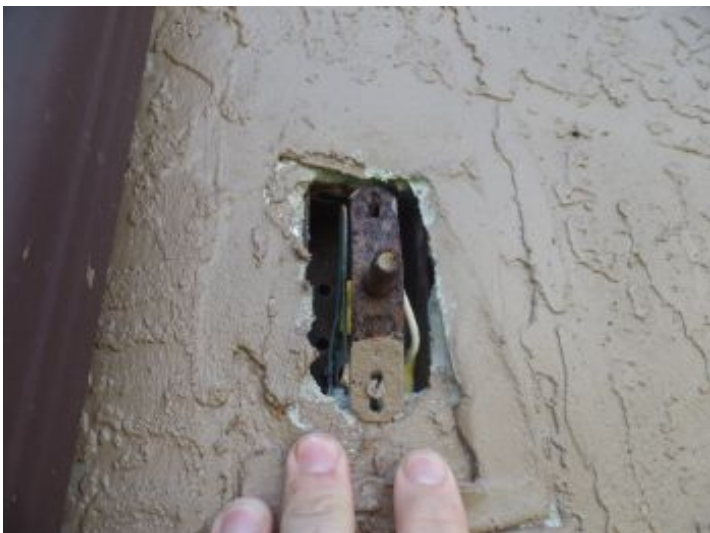
Open box at rear left exterior wall ( missing fixture )

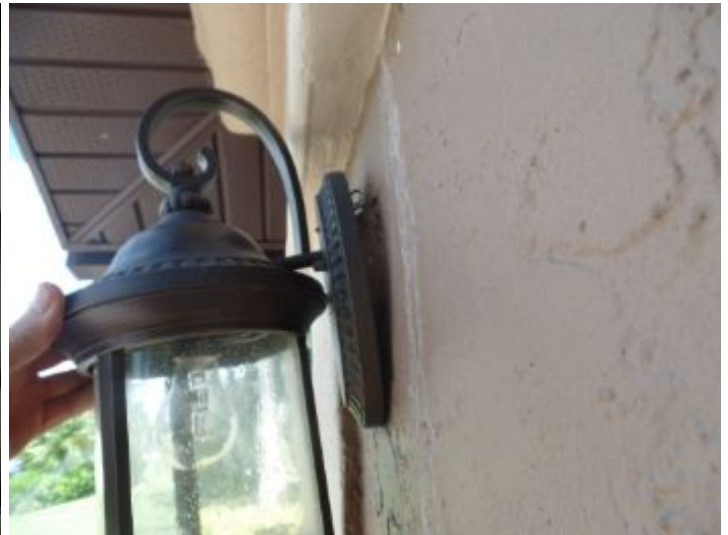
Recommend sealing light fixtures at garage front walls to the stucco wall to help prevent water intrusion

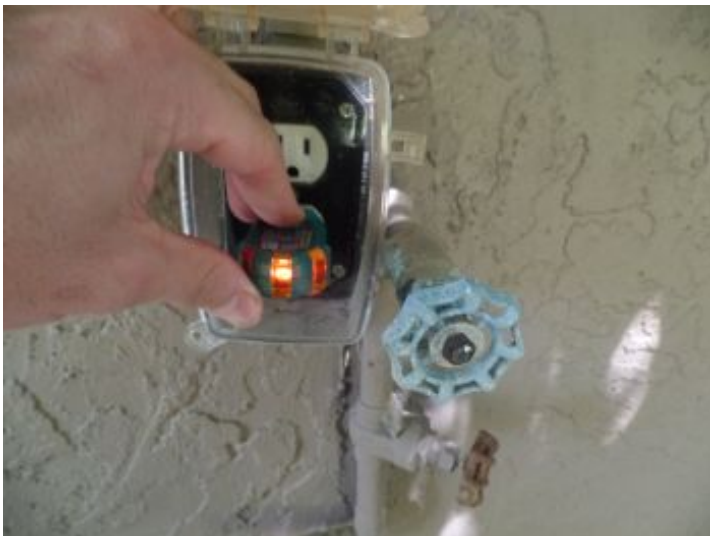
There is no GFCI (Ground Fault Circuit Interrupter) protection for all recommended electrical outlets in the utility room or right side exterior

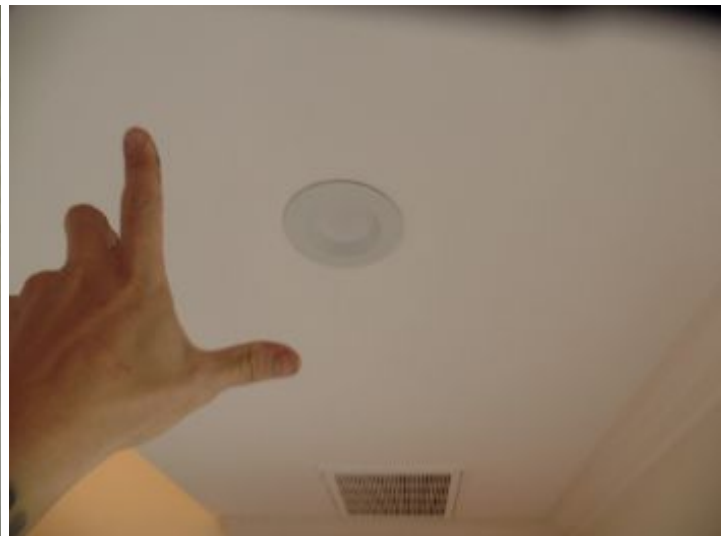
The front entry light fixture did not respond to the control. This could be a burnt/ missing bulb or a dead circuit

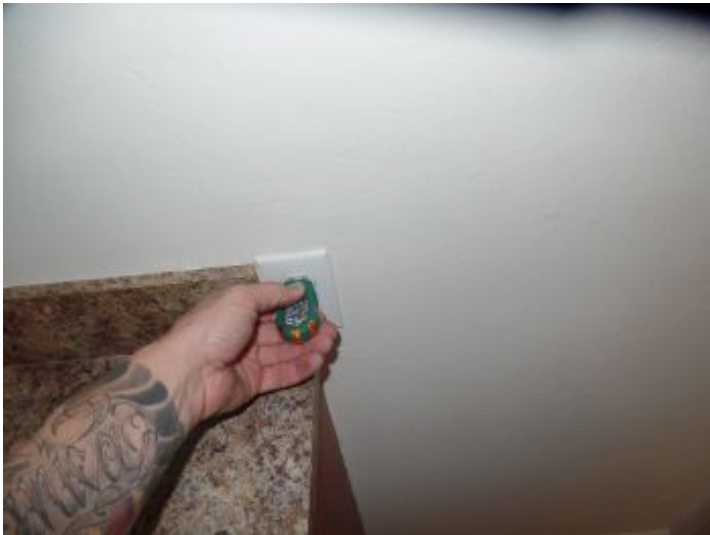
There is no GFCI (Ground Fault Circuit Interrupter) protection for all recommended electrical outlets in the utility room or right side exterior

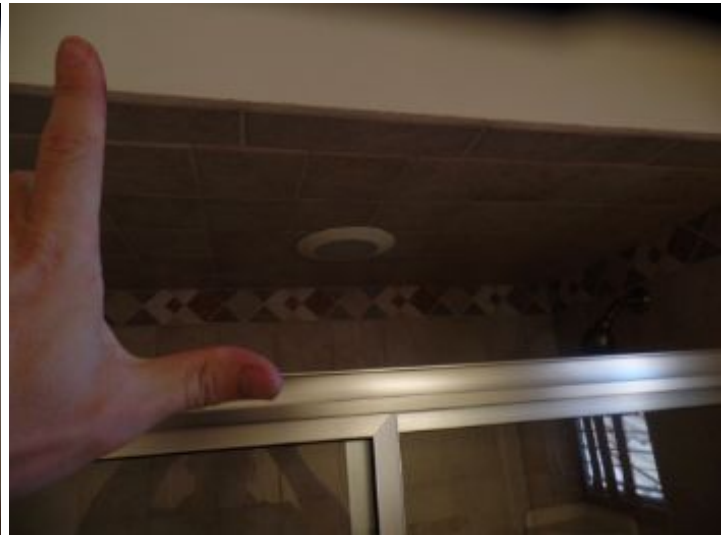
The guest bath ceiling light fixture did not respond to the control. This could be a burnt/ missing bulb or a dead circuit

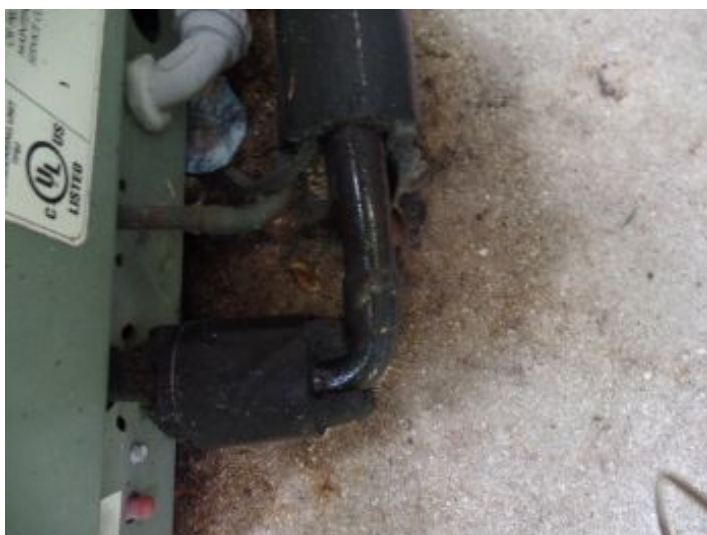
Refrigerant lines insulation is deteriorating at the outside units

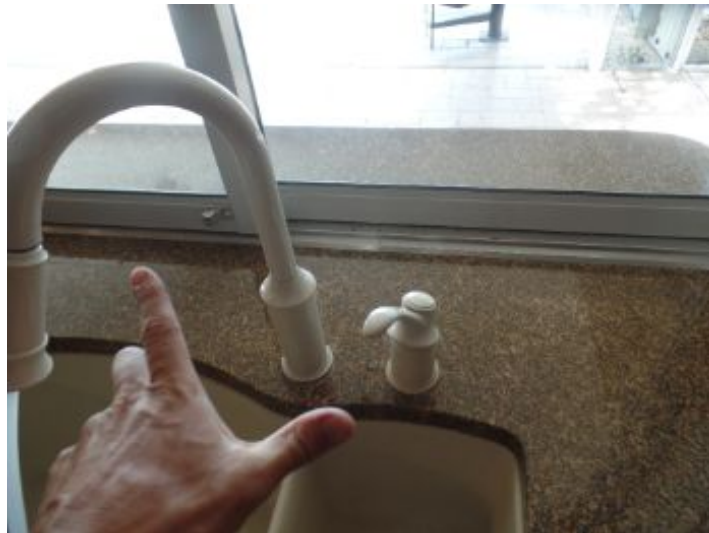
Kitchen faucet and handle were loose to counter top. Handle was worn

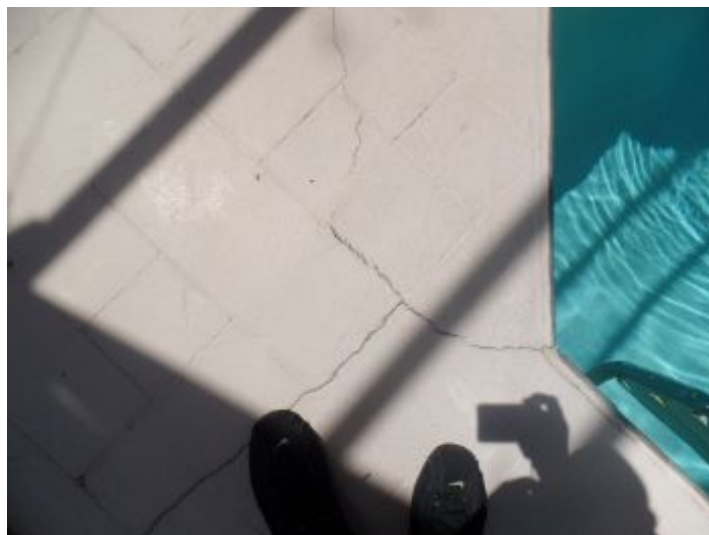
Minor cracks / holes (1/4" or less) present in pool deck slab. Generally speaking, cracks that are less than 1/4" are not commonly regarded as being structurally significant. Nonetheless, they should be monitored to see if there is active movement in this area

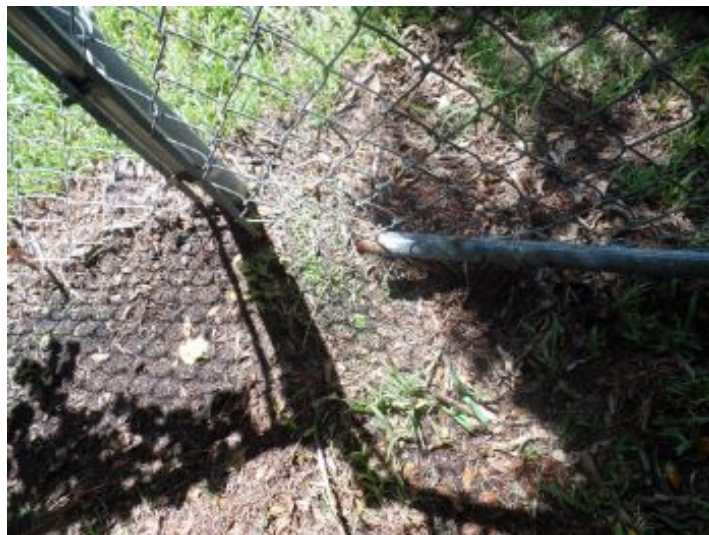
Fence damaged at front right of home
